DOUGLAS REPORT DAC-56499

NARRATIVE END ITEM REPORT

SATURN S-IVB-208

JUNE 1968

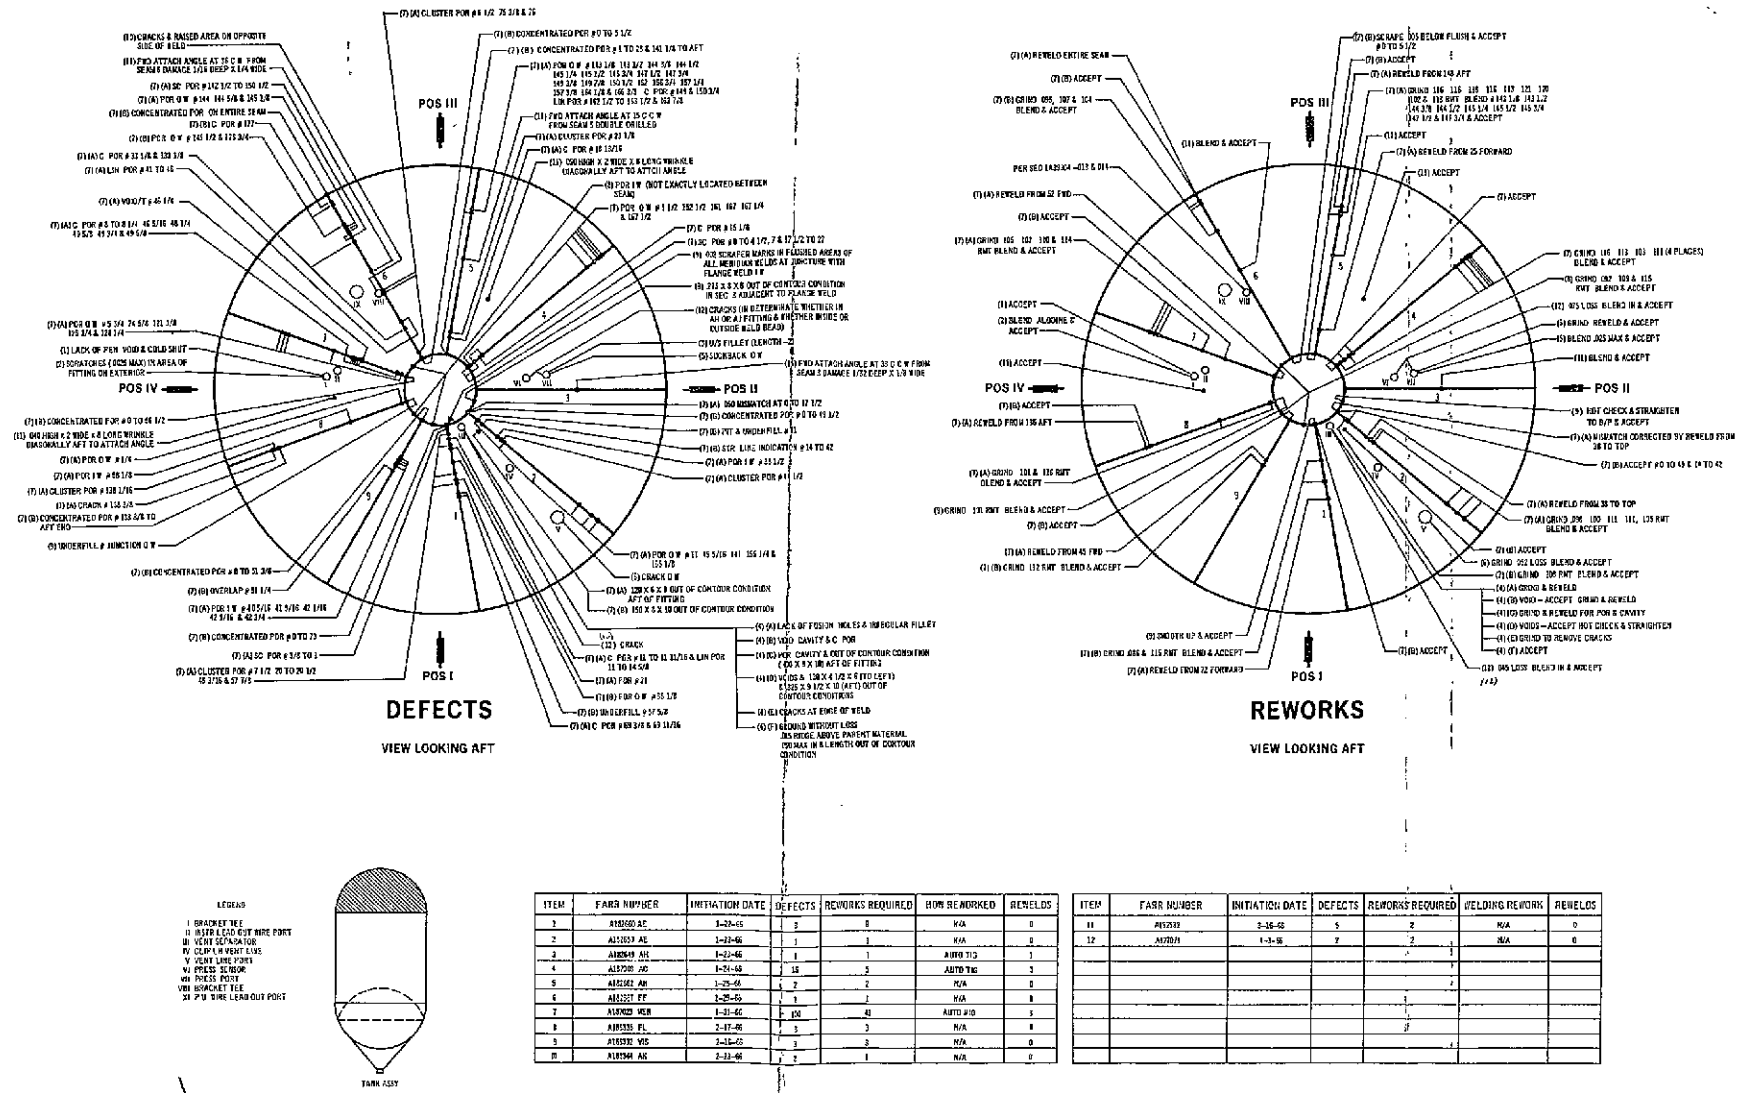
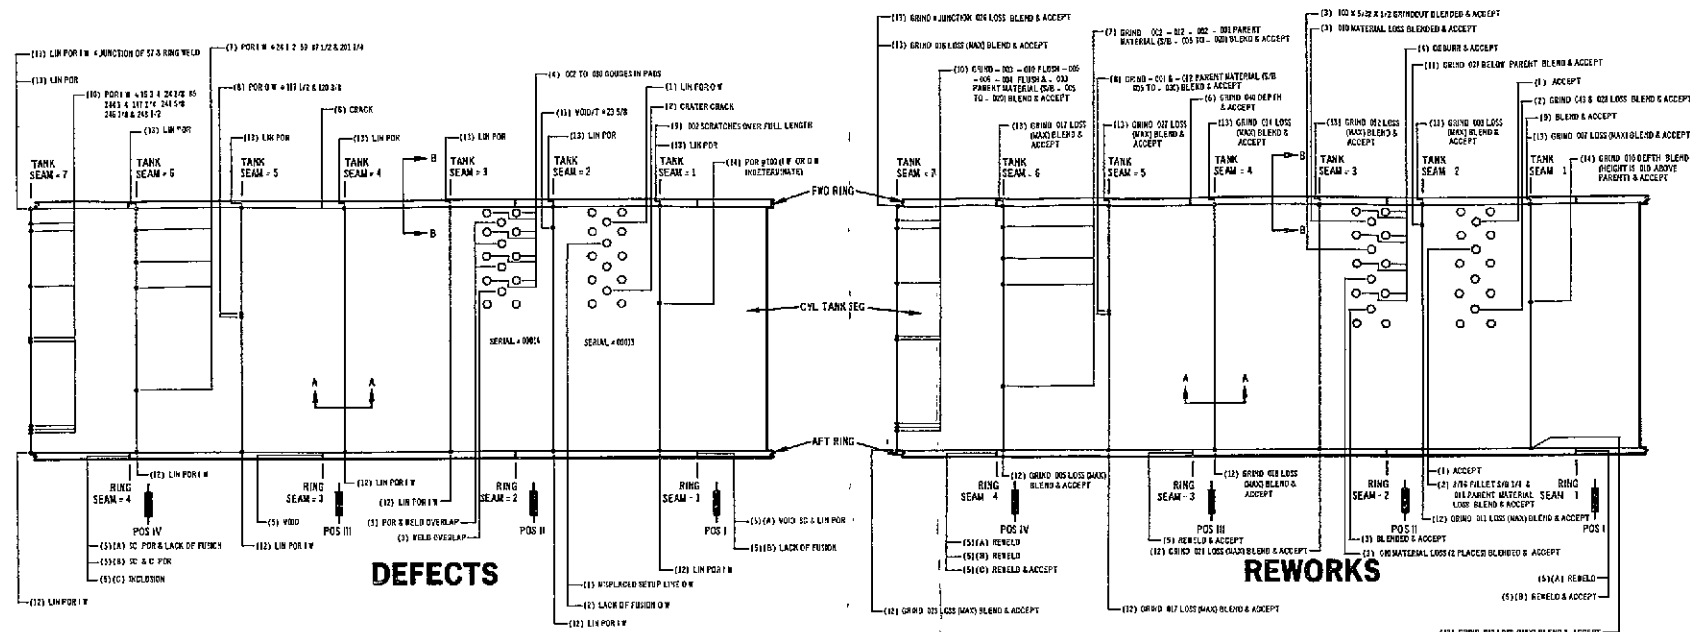
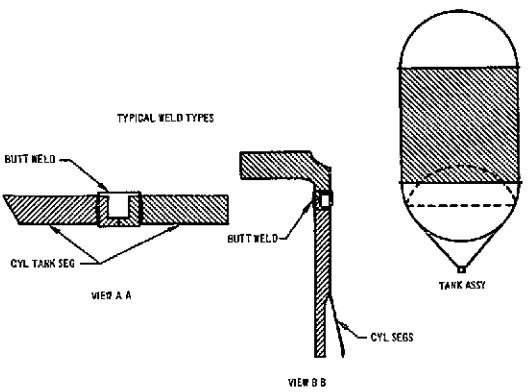
Chart 1. Forward Dome Assembly

ITEM	FARR NUMBER	INITIATION DATE	DEFECTS	REWORKS REQUIRED	WELDING REWORK	RFPELOS
(12)	A17757	09-06-01	2	0	N/A	0
(21)	A17757	01-1-05	3	3	N/A	0
(27)	A17757	01-1-05	1	7	N/A	0
(41)	A17757	01-11-05	0	8	N/A	0
(59)	A17757	07-1-05	0	0	REWORKING	0
(60)	A17757	02-15-05	1	1	N/A	0
(71)	A17757	1-1-06	1	4	N/A	0
(85)	A17757	1-1-06	2	7	N/A	0
(120)	A17757	1-1-06	1	1	N/A	0
(121)	A17757	1-1-06	0	0	N/A	0

ITEM	FARR NUMBER	INITIATION DATE	DEFECTS	REWORKS REQUIRED	WELDING REWORK	RFPELOS
(121)	A17757	1-1-06	1	1	N/A	0
(122)	A17757	1-1-06	7	7	N/A	0
(123)	A17757	1-1-06	8	8	N/A	0
(124)	A17757	1-1-06	1	1	N/A	0

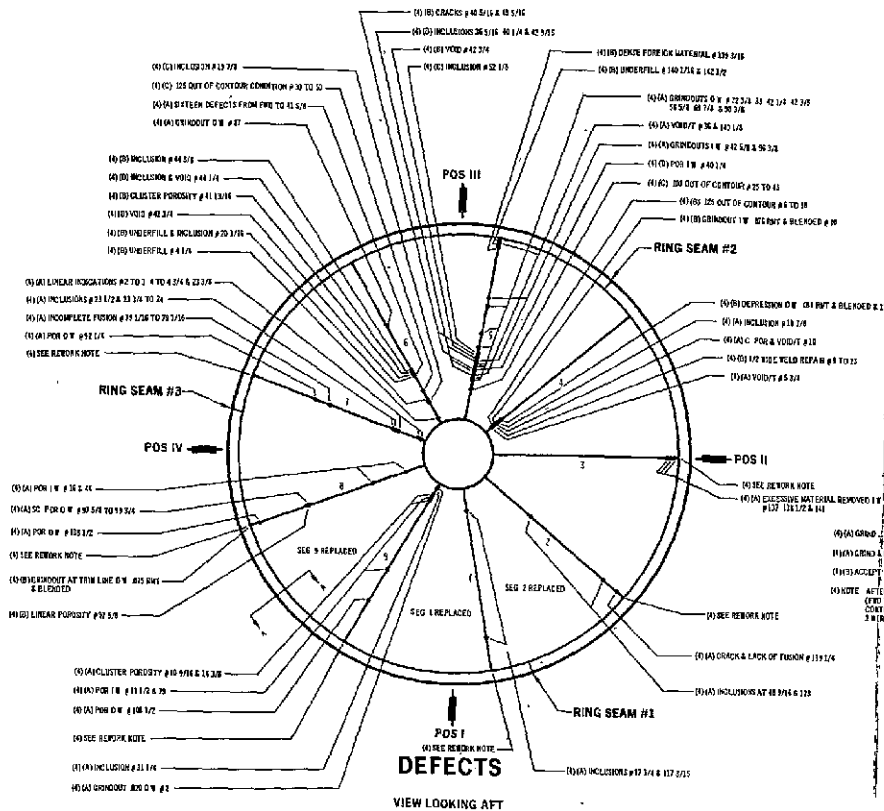
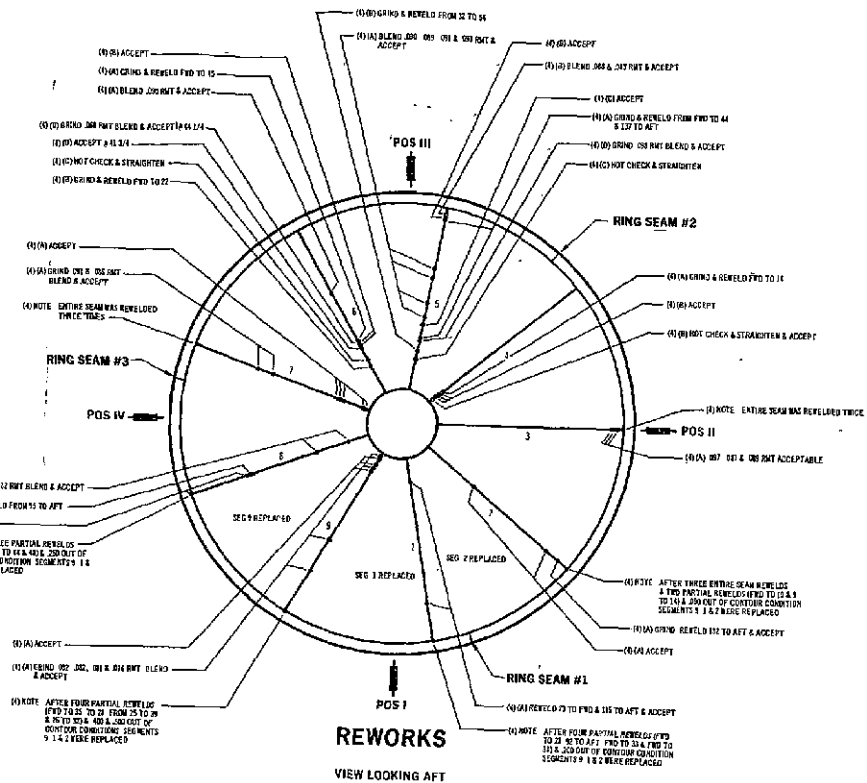
Chart 2. Cylindrical Tank Assembly

NOTE A - ALL SEAMS WERE ORIGINALLY WELDED & SEAMS 1, 4, 5 & 6 WERE REPAIRED
WHEN THE
B - SEAMENTS 1 & 2 WERE REPLACED & SEAM 3
SEAMS 1 & 2 WERE REPLACED
REPAIR
